**Intel 450KX/GX PCIset
Specification Update
82454KX/GX (PB)
82453KX/GX (MC)
82452KX/GX (DP)
82451KX/GX (MIC)**

Release Date: August 1998

Order Number: 243109-015

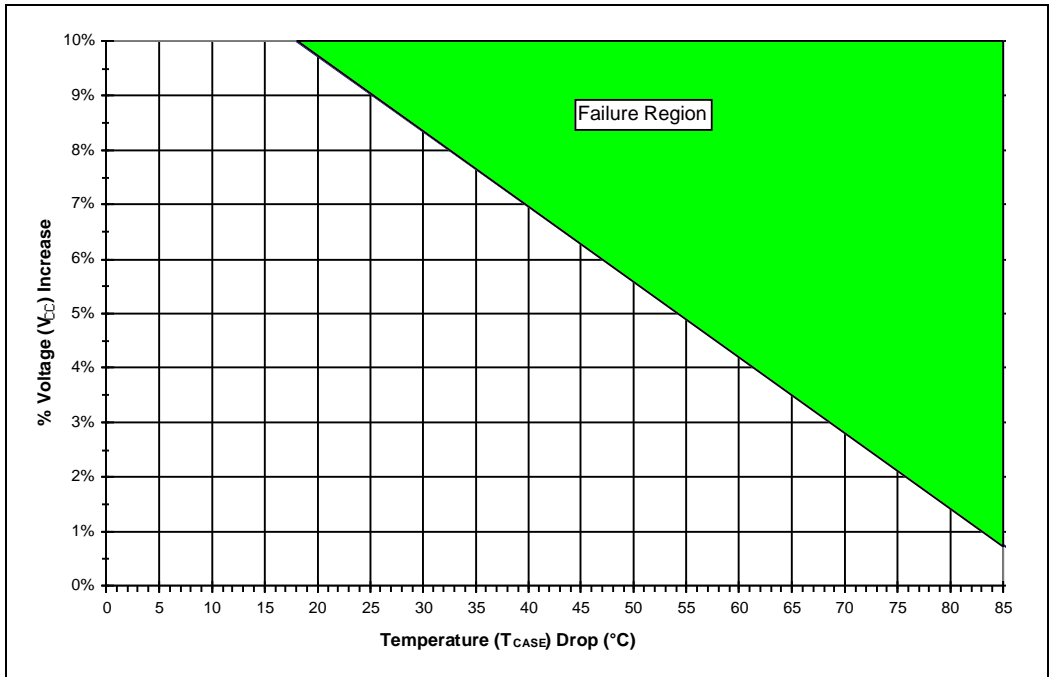
Figure 1. V_{CC} Increase vs. T_{CASE} Drop for DPLL Failure (Worst Case)

36. *T_{CASE} Drop Plus Voltage Swing May Cause DPLL Failure*

PROBLEM: Analysis of the DPLL (Digital Phase Lock Loop) units of the Intel 450KX PCIsset components has shown that a DPLL failure can occur during certain changes in temperature and/or voltage within the Intel 450KX PCIsset component specification, resulting in a loss of DPLL functionality for between 2 and 500 bus clocks.

After a device has undergone a hard reset of the DPLL (via the PLLRST pin), a drop in T_{CASE} accompanied by an increase in V_{CC} may cause this erratum to occur. The magnitude of the temperature drop and supply voltage increase required to cause this failure is graphed below:

IMPLICATION: If the T_{CASE} of any Intel 450KX PCIsset component is allowed to decrease by more than 18°C after the point at which DPLL lock is obtained after a DPLL hard reset, a positive voltage swing may cause the component to lose its internal clock for 2 - 500 processor bus clocks. This may result in a system hang, lost data, or other unpredictable system failure (note that if the component is not processing commands or data for the time during which the internal clock is lost, no failure will be observed). The larger the temperature drop and/or voltage swing, the more likely the failure.

If V_{CC} swings from 3.3 V -5% to 3.3 V +5%, and T_{CASE} does drop more than 18 °C past the temperature at which the DPLL was reset, this erratum may occur. Similarly, if T_{CASE} transitions from 85 °C (at DPLL reset time) to 0 °C, a swing in V_{CC} of more than 0.5% may cause this erratum. Thus, maintaining a moderately constant T_{CASE} and V_{CC} will prevent this erratum, as per the graph above.

WORKAROUND: Ensure that the DPLL reset occurs during a period where the T_{CASE} is low and/or the V_{CC} is high relative to normal operational conditions (e.g., if the system is running at a high temperature and is powered down, allow it to cool before powering up again). Alternately, ensure that the system meets a restricted specification for changes in T_{CASE} and V_{CC} .

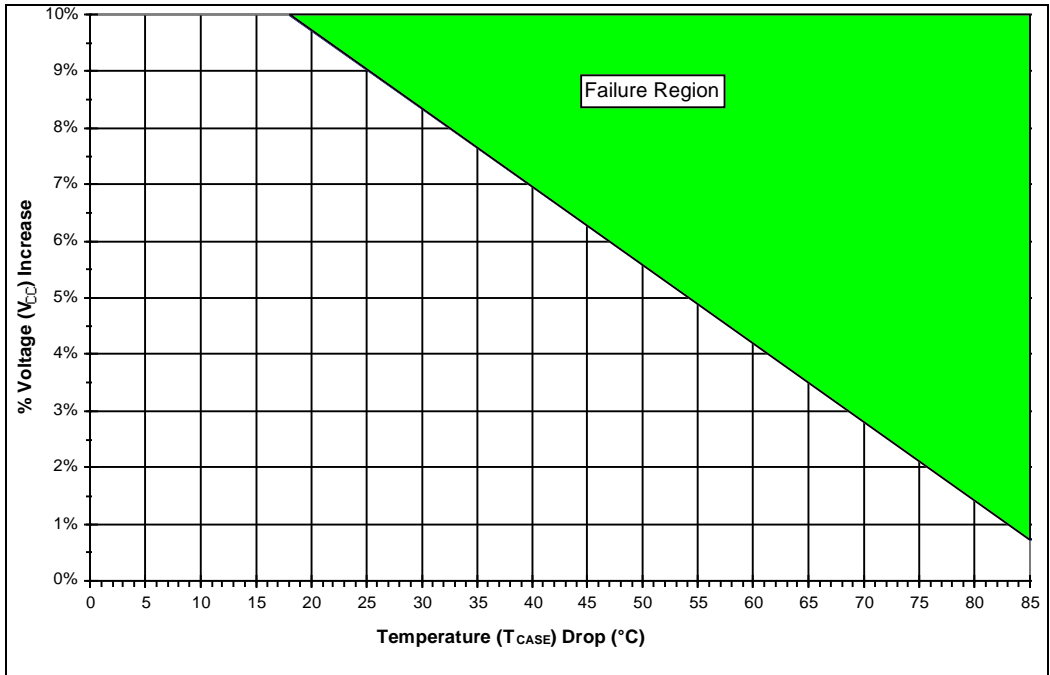
Figure 1. V_{CC} Increase vs. T_{CASE} Drop for DPLL Failure (Worst Case)

The current specification states that the Intel 450GX PCIsset is operational over a T_{CASE} range of 0 - 85 °C and a V_{CC} range of 3.3 V ± 5%.

After a device has undergone a hard reset of the DPLL (via the PLLRST pin), a drop in T_{CASE} accompanied by an increase in V_{CC} may cause this erratum to occur. The magnitude of the temperature drop and supply voltage increase required to cause this failure is graphed below:

IMPLICATION: If the T_{CASE} of any Intel 450GX PCISSET component is allowed to decrease by more than 18 °C after the point at which DPLL lock is obtained after a DPLL hard reset, a positive voltage swing may cause the component to lose its internal clock for 2 - 500 processor bus clocks. This may result in a system hang, lost data, or other unpredictable system failure (note that if the component is not processing commands or data for the time during which the internal clock is lost, no failure will be observed). The larger the temperature drop and/or voltage swing, the more likely the failure.
