Monthly Specification Update

Intel® Server Board S3420GP

Intel Order Number E82362-008

October 2011

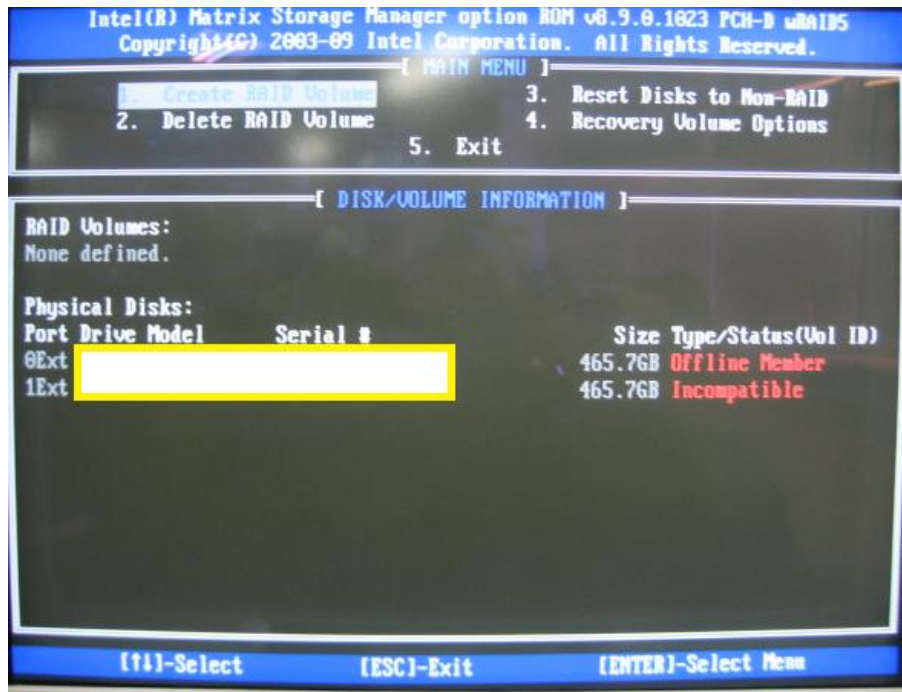
Problem Under RAID 1 mode, if the operating system does reboot after one HDD is unplugged, the other HDD will show incompatible status even after the other HDD is plugged in again.

Implication Please refer to the picture below.

Status This issue was fixed in BIOS version 0048.

Workaround Downgrade BIOS to version 0042 when the issue is happening.
