Monthly Specification Update

Intel® Server Board S3420GP

Intel Order Number E82362-006

May, 2011

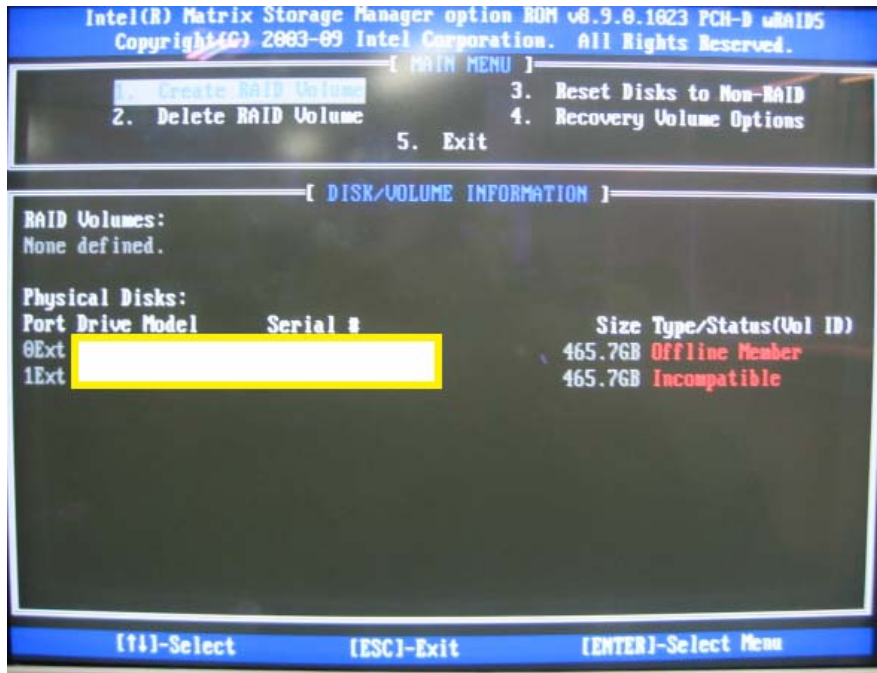
21. Intel® Matrix Storage Manager of Intel® Rapid Storage Technology (Intel® RST) may show HDD incompatible status under certain conditions

Problem	Under RAID 1 mode, if the operating system does reboot after one HDD is unplugged, the other HDD will show incompatible status even after the other HDD is plugged in again.
Implication	Please refer to the picture below.

Status This issue was fixed in BIOS version 0048.

Workaround Downgrade BIOS to version 0042 when the issue is happening.
