Monthly Specification Update

Intel® Server Boards S5520HC, S5520HCT and S5500HCV

Intel Order Number E68105-012

December, 2010

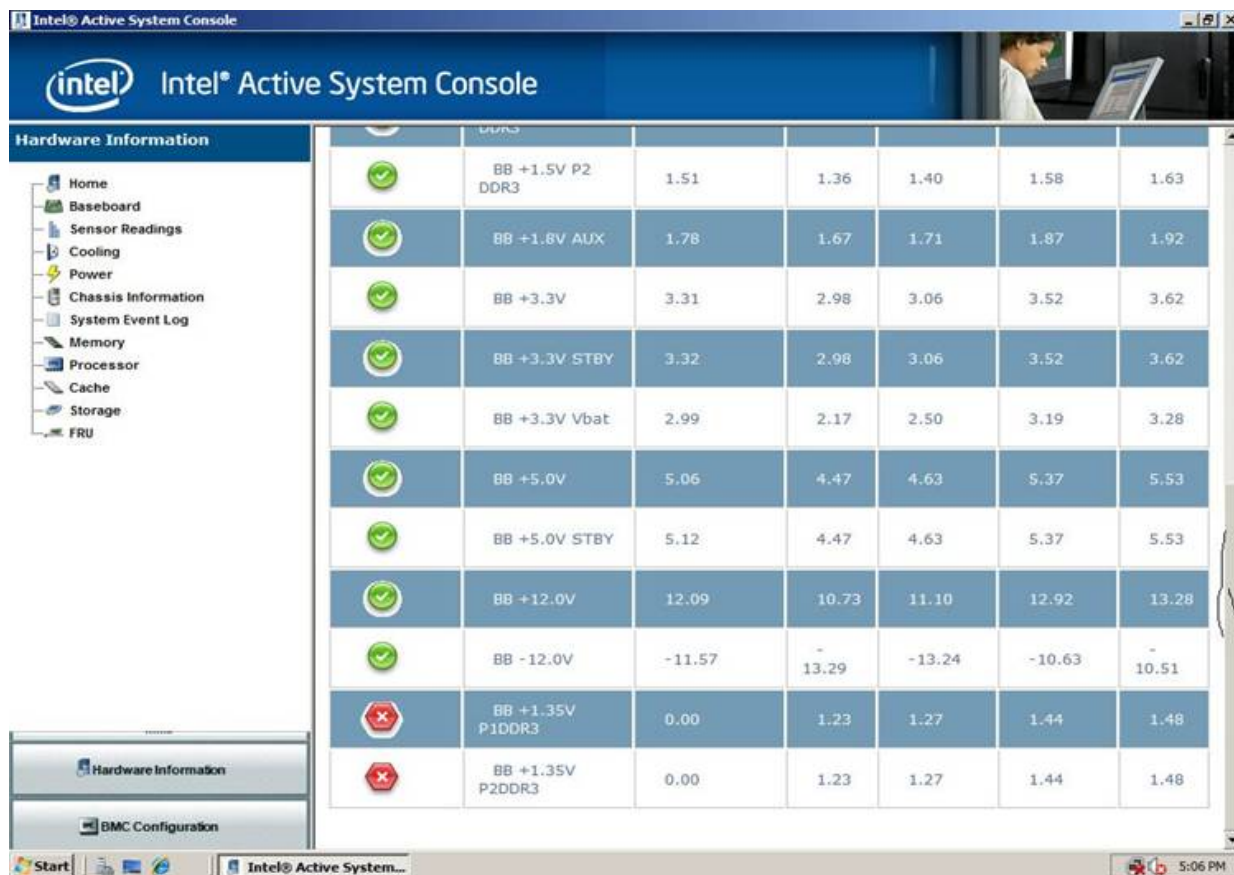
27. Intel® Active System Console (IASC) 3.5.1 and 3.5.2 may fail to detect status of memory voltage sensors

Problem	Intel® Active System Console (IASC) v3.5.1 and v3.5.2 is used to monitor hardware status on Intel server system. Intel® Xeon® 5500 Series Platforms start to support low voltage memory DIMM, so current FRUSDR has contained four memory voltage sensors "BB+1.5v P1DDR3", "BB+1.5v P2DDR3", "BB+1.35v P1DDR3" and "BB+1.35v P2DDR3", When system has 1.5v memory or 1.35v memory, only corresponding memory voltage sensors will be enabled, the other type memory voltage sensors will be disabled. IASC cannot judge the status of memory voltage sensors which have been disabled, and still try to detect those sensors reading. Because sensor reading is "0", lower than its threshold, so IASC shows those sensors status as critical warning. A screenshot of this failure is shown below:
---------	--

Implication IASC fails to judge the status of disabled sensors and still considers those sensors to server health algorithm.

Status This issue may be fixed in future IASC release.
