Monthly Specification Update

Intel® Workstation Board S5520SC

Intel Order Number E68106-016

December, 2010

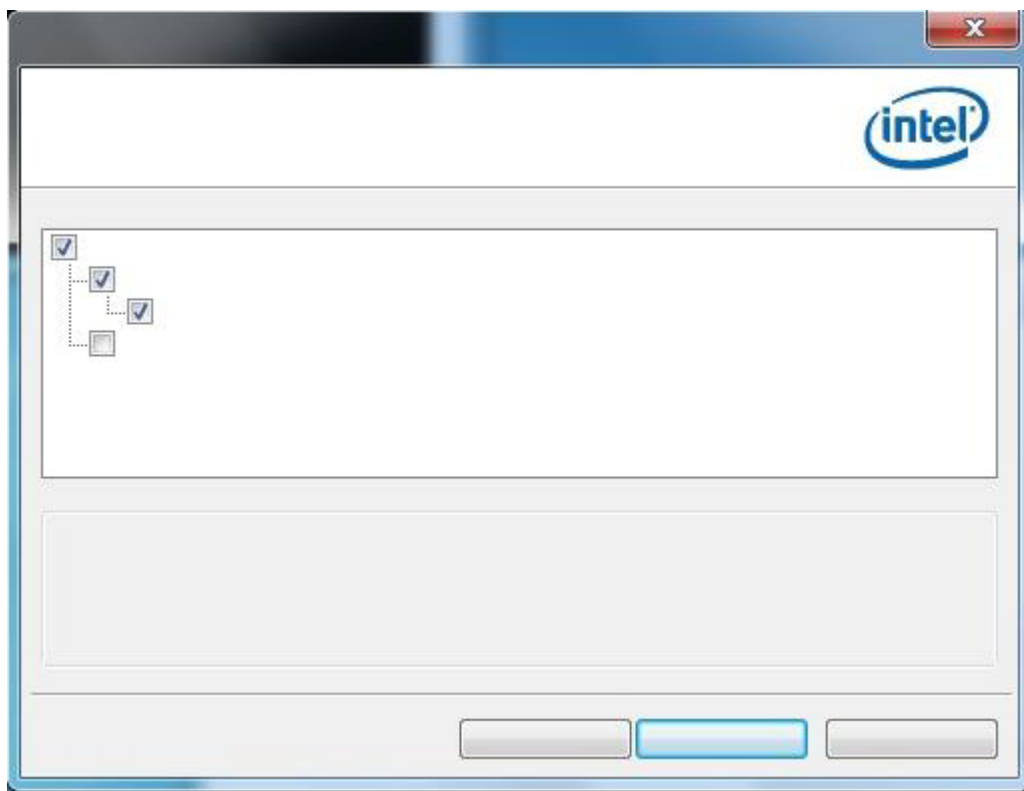
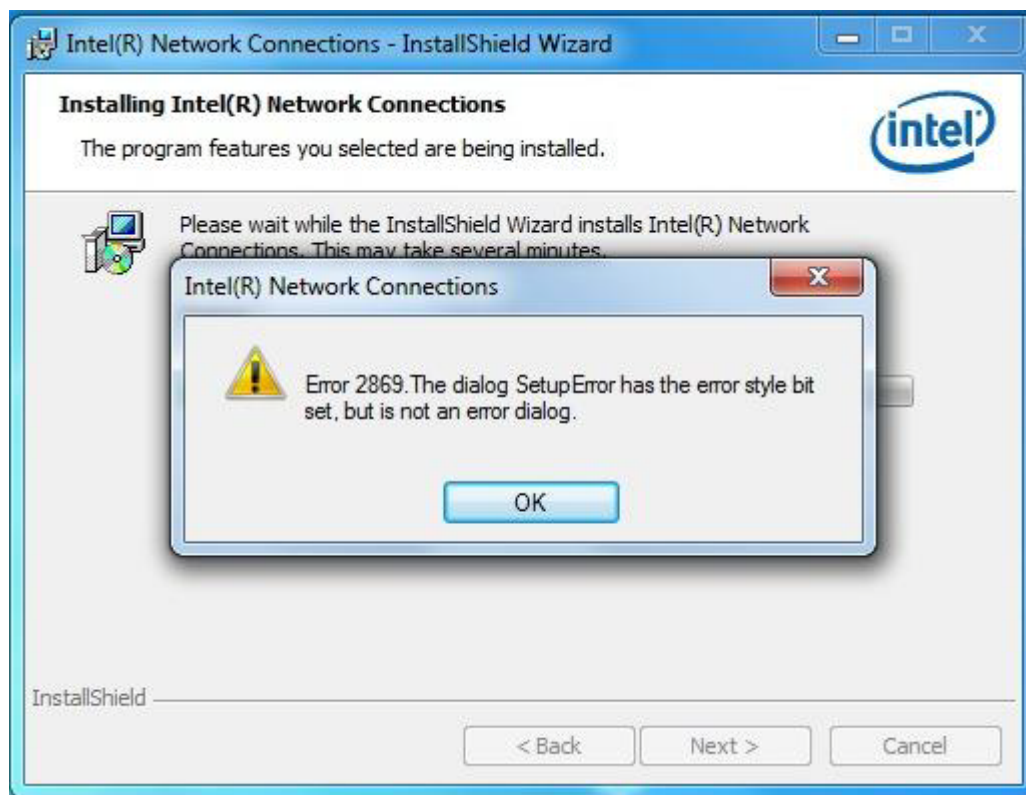
30. NIC driver 15.1.1 may not be installed properly in Microsoft Windows Vista* or Microsoft Windows 7*

Problem	Users may find onboard NIC (Network Interface Card) driver version 15.1.1 may not get installed properly in Microsoft Windows Vista* or Microsoft Windows 7* when UAC (User Access Control) is set as "Default". Problem may occur during the installation process of the NIC driver, scramble display and unexpected message may display as following:
---------	---

- Implication** This is a permissions issue with Microsoft Windows Vista* and later operating systems. Permissions don't get elevated installing with PROSETDX.MSI, which is the file the batch file in the root directory points to. DXsetup gets the permissions elevated on Microsoft Windows Vista* and later operating systems, but they don't get elevated if you launch the MSI without DXsetup.
- Status** This issue will be fixed by future NIC driver release.
- Workaround** The following workaround can be used to navigate around the issue.
1. Users can browse to the \apps\prosetdx\<os version> directory in the NIC driver package and launch DxSetup.exe.
 2. Users can also refer to below picture to set Windows UAC (User Account Control) to "Never notify", re-install the driver after a system reboot.
