Monthly Specification Update

Intel® Workstation Board S5520SC

Intel Order Number E68106-017

January, 2011

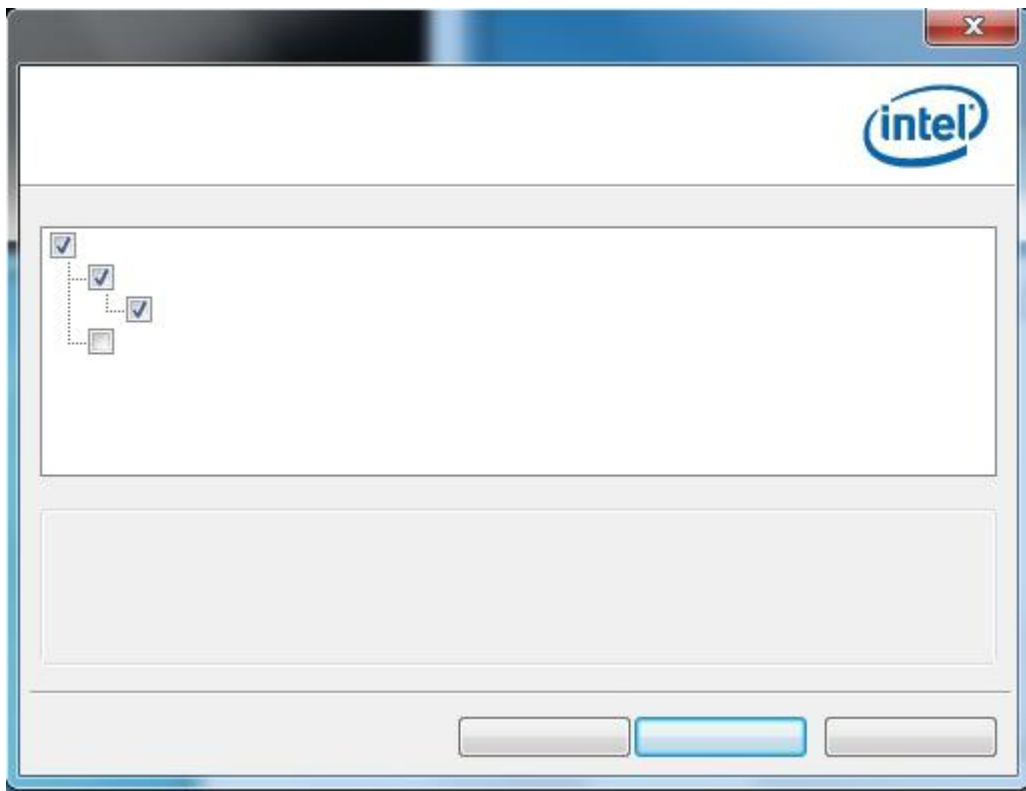
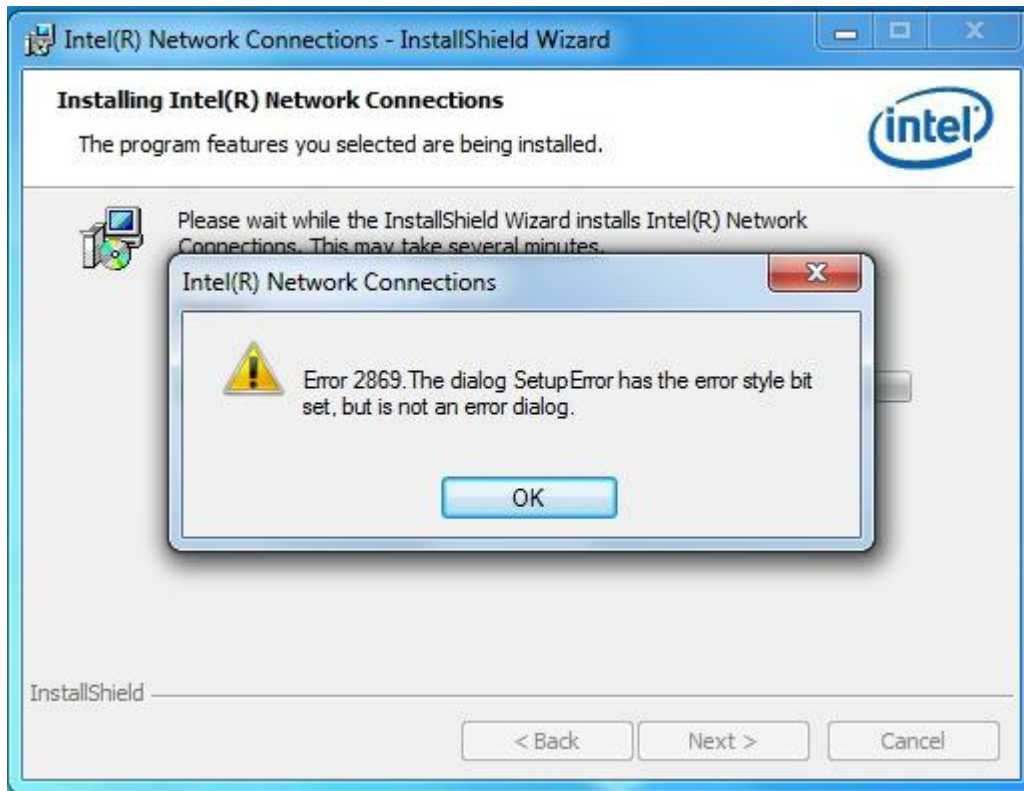
30. NIC driver 15.1.1 may not be installed properly in Microsoft Windows Vista* or Microsoft Windows 7*

Problem	Users may find onboard NIC (Network Interface Card) driver version 15.1.1 may not get installed properly in Microsoft Windows Vista* or Microsoft Windows 7* when UAC (User Access Control) is set as "Default". Problem may occur during the installation process of the NIC driver, scramble display and unexpected message may display as following:
---------	---

- Implication** This is a permissions issue with Microsoft Windows Vista* and later operating systems. Permissions don't get elevated installing with PROSETDX.MSI, which is the file the batch file in the root directory points to. DXsetup gets the permissions elevated on Microsoft Windows Vista* and later operating systems, but they don't get elevated if you launch the MSI without DXsetup.
- Status** This issue will be fixed by future NIC driver release.
- Workaround** The following workaround can be used to navigate around the issue.
1. Users can browse to the \apps\prosetdx\ - 2. Users can also refer to below picture to set Windows UAC (User Account Control) to "Never notify", re-install the driver after a system reboot.
