# Monthly Specification Update

Intel® Server Board S5520UR

*Intel Order Number E69054-001*

**March 2011**

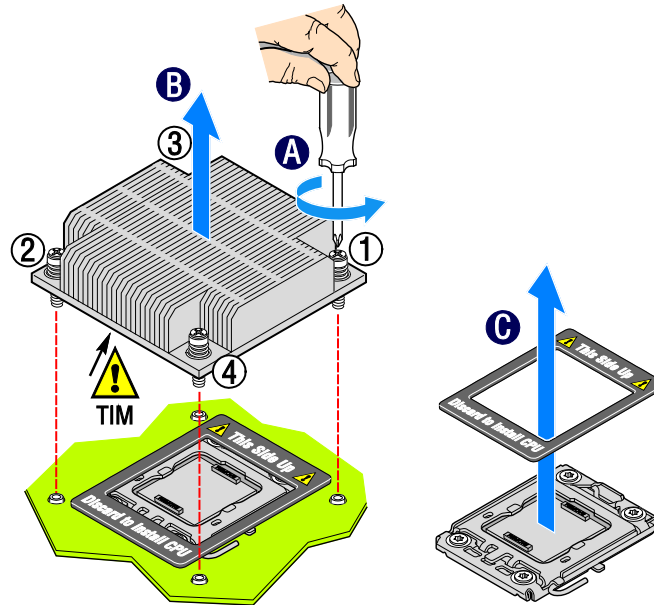
**Figure 1. Removing the Heatsink**

**Problem:** The current documentation does not properly describe the installation and removal of the heatsink. Careful insertion and removal of the heatsink is required to prevent damage to the heatsink screws or backplate.

**Implication:** There is a possibility of damage to the heatsink if proper steps are not followed.

1. Loosen the four captive screws on the heatsink corners in a diagonal manner according to the numbers shown in figure 1 as follows:
  - Starting with the screw at location 1, loosen it by giving it **two rotations** in the anticlockwise direction and stop. (**IMPORTANT:** Do not fully loosen.)
  - Proceed to the screw at location 2 and loosen it by giving it two rotations and stop.
  - Loosen screws at locations 3 and 4 by giving each screw two rotations and then stop.
  - Repeat steps 1a through 1c by giving each screw two rotations each time until all screws are loosened.
2. Do one of the following:
  - If removing the heatsink for the first time, do the following:
    - i. Lift the heatsink from the board.
    - ii. Remove and discard the spacer (see letter “C” in figure 1).
