Monthly Specification Update

Intel® Server Boards S2600WP Family
Intel® Server Systems H2000WP Family

Intel Order Number G64830-005

May, 2013

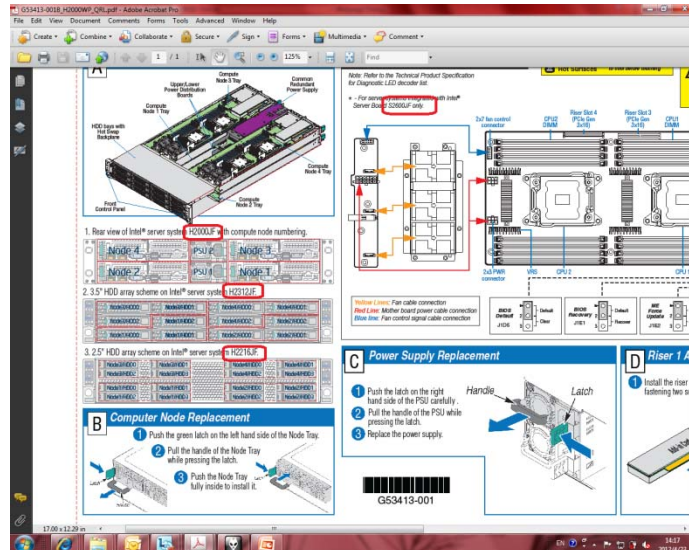
Problem	The Intel® Server System H2000WP family Chassis Quick Reference(document ID G53413-001) has 4 incorrect picture titles as shown below. The correct title name should be "H2000WP", "H2312WP" "H2216WP" and "S2600WP". All schemes and configuration diagrams are correct for H2000WP. The impacted servers systems are listed below. The updated Chassis Quick Reference (document ID G53413-002) has fixed this problem. The impacted server systems are list in the table
---------	---

The Chassis Quick Reference with incorrect picture titles

Implication The picture tiles do not match the pictures.

Status This issue was fixed with G53413-002.

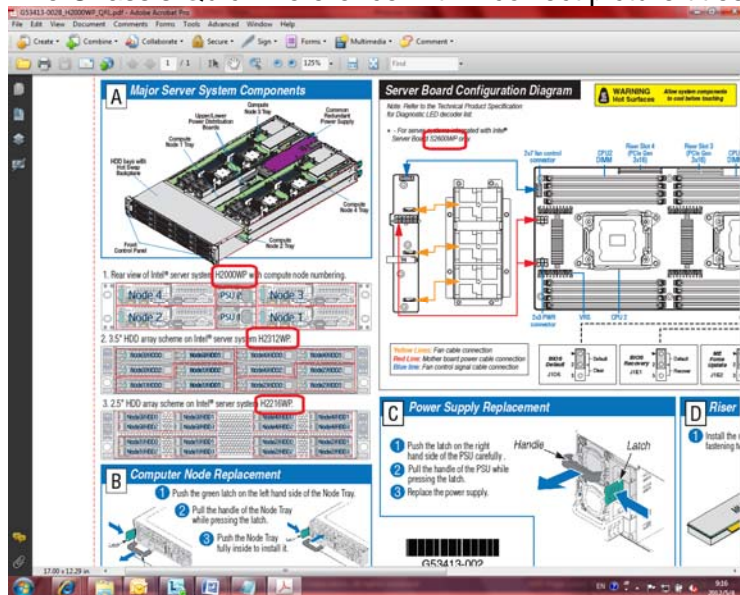
The Chassis Quick Reference with updated picture titles
