Monthly Specification Update

**Intel® Server Board S2400EP Family, Intel®
Server System R1000EP Family**

December, 2012

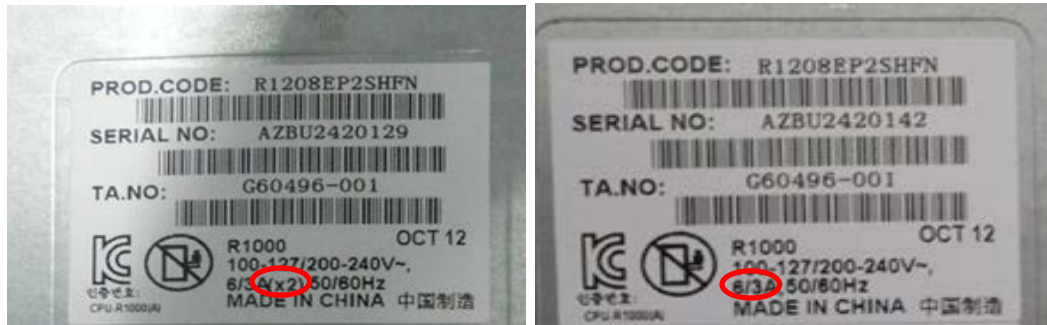
27. Intel® server system R1000EP COO label includes inaccurate information

Problem	Intel® server system R1000EP COO label includes redundant information that needs to be removed.
Implication	There is “x2” follwing powerating “6/3A”, which is showed in the left snapshot. The correct label should be as the right snapshot indicates.

Status This issue may be fixed in future shipment.
