# Monthly Specification Update

**Intel<sup>®</sup> Server Board S5000PAL**

*Intel Order Number D65289-033*

**April 2010**

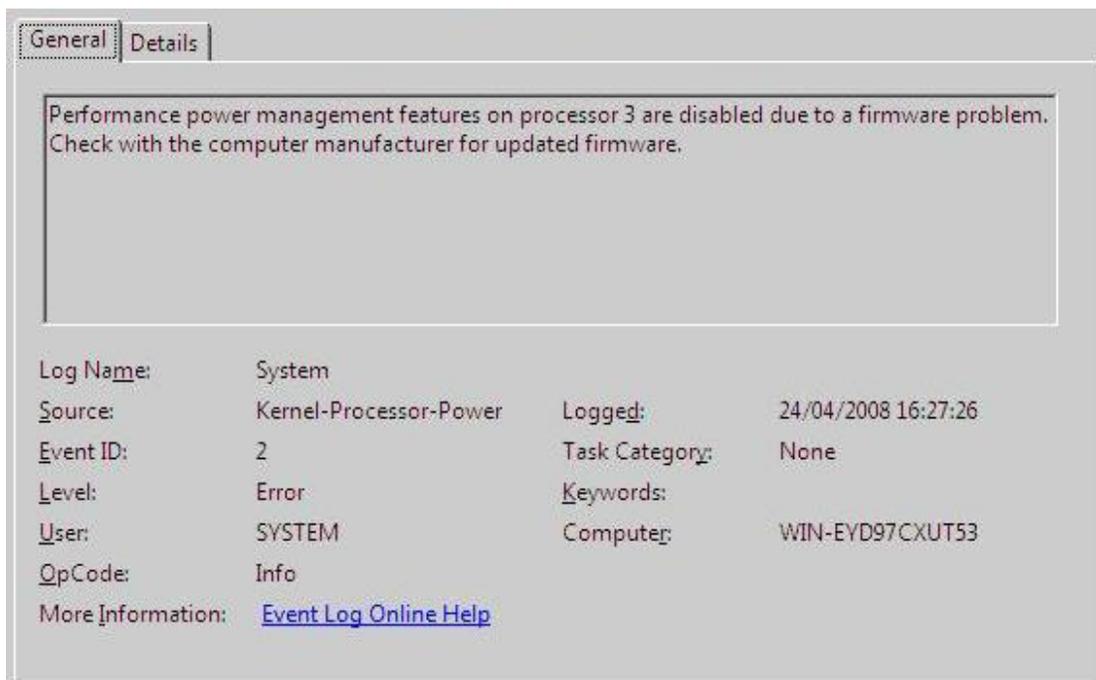
Problem	If you are use any Intel® Xeon® Processor of the 5300 or the 5400 series in the Intel® S5000PAL Server Board and install Microsoft Windows Server 2008* on the system, you may encounter the following error in the Windows* event log:
---------	---

The Event Error is related to a change in Microsoft's validation and logging of supported P-States for a processor. The wording of the error that is displayed is misleading. There is no performance impact. Microsoft logs the error because the BIOS has a default PSS object (P-State info) in the ACPI space for these processors. Basically, this default PSS object indicates no P-State is supported. However, Microsoft Windows Vista\* and Microsoft Windows Server 2008\* have changed their interpretation of this table.

Implication BIOS version 88 or even an earlier version may produce this erratum.

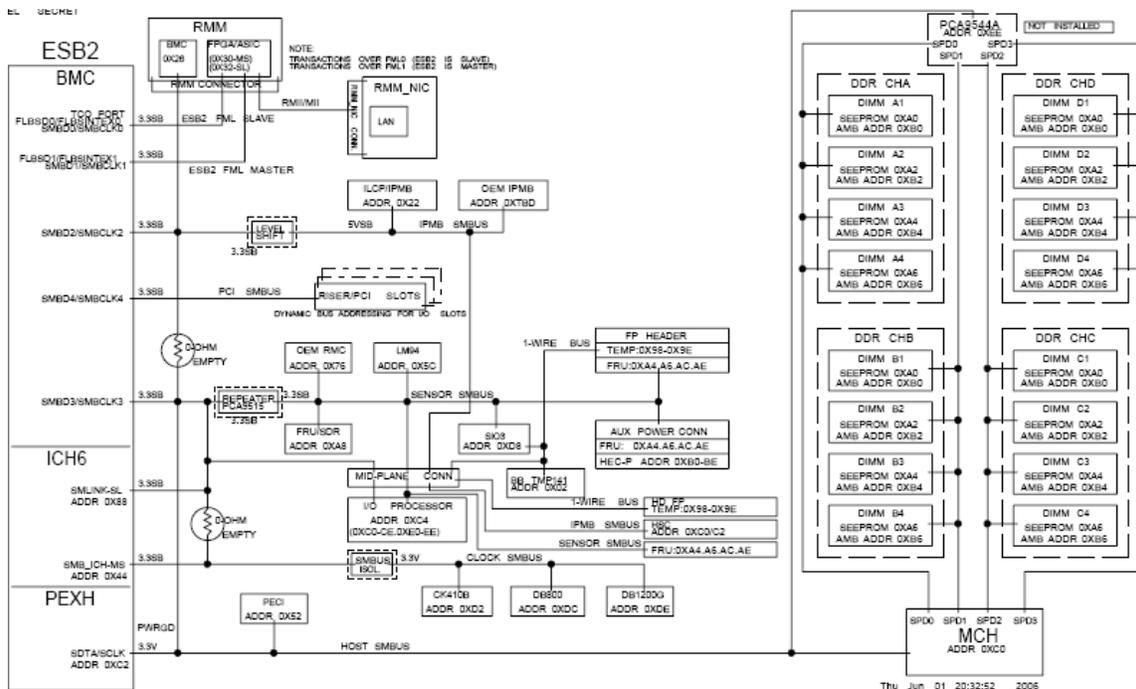
- Add PECI controller
- Remove separate HSC connector
- Correct Midplane -> FP SMBus connections and 1-wire temp sensor
- Correct SMBus and 1-wire temp sensor connections to FP connector
- Correct FBDIMM labeling

The corrected diagram is shown:

**Implication:** Inaccurate understanding of actual server board design with respect to the specified diagram.

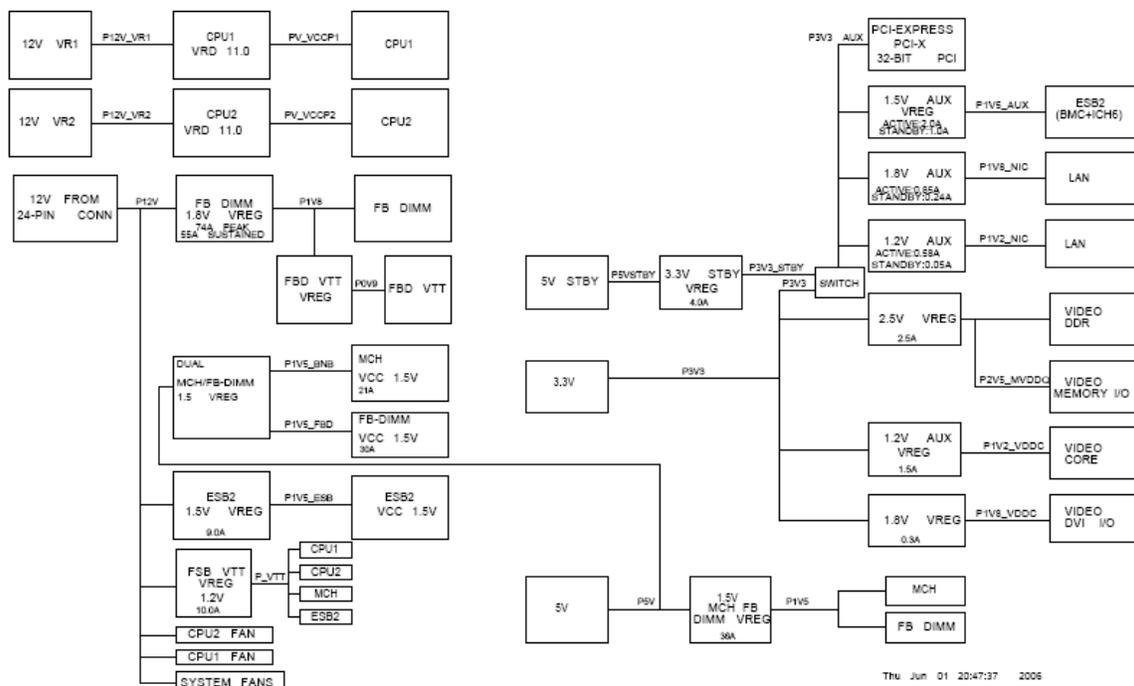
- MCH/FBDIMM 1.5 Vreg moved from 12 V rail to 5 V rail.
- Video Memory Vreg corrected to only one 2.5 V reg. instead of two.
- “ATI” label for Video components changed to generic “Video”.

The corrected diagram is shown:

Implication: Inaccurate understanding of actual server board design with respect to specified diagram.

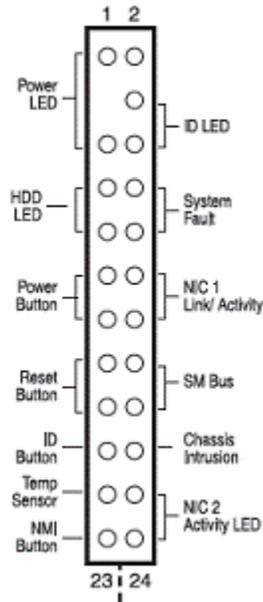
Problem: The current diagram incorrectly lists a cooling status pin, does not have the temperature sensor listed, and shows incorrect locations for the ID LED. The corrected diagram is shown:

Implication: This is a typo.
