Monthly Specification Update

Intel® Server Boards S5500HV

Intel® Server System SR1670HV

Intel Order Number E77965-001

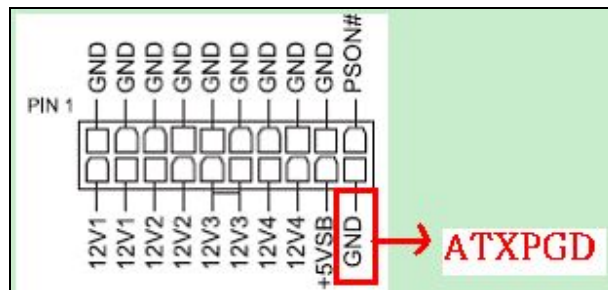
1. One power connector pin-outs definition in TPS is not correct

One power connector pin-outs definition is not correct,

Please refer below revision

This correction will be implemented in next TPS revision 1.1.
