# Monthly Specification Update

***Intel® Server Boards S5500HV***

***Intel® Server System SR1670HV***

*Intel Order Number E77965-003*

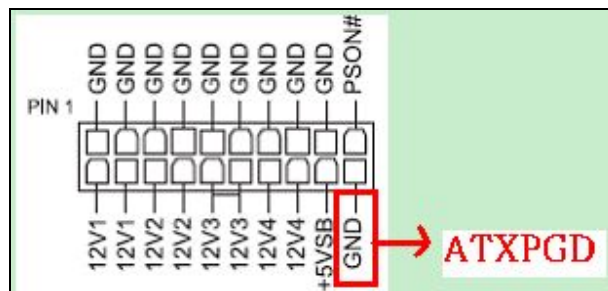
### 1. One power connector pin-outs definition in TPS is not correct

One power connector pin-outs definition is not correct,

Please refer below revision

This correction has been implemented in TPS revision 1.1.
