Intel Technical Advisory

TA-0948-1

April 2, 2010

Intel® Server Systems SR1625, SR2600, and SR2625 may not be able to load Linux OS or IDA from Optical Drive

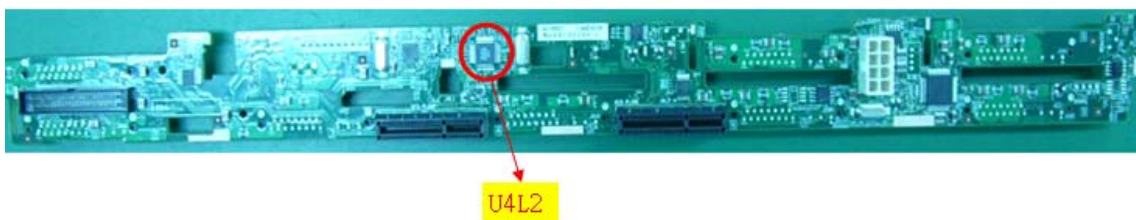
Figure 1: SR1625 Backplane (PBA# E27104-403) - Location U4L2

The backplanes suspected to be built with the incorrect GL830 can first be identified by the system serial number list above. To confirm, the markings of the GL830 converter must be visually inspected. The GL830 is located on the rear of each backplane as shown in figures one, two and three. For each system, this component is visible after removing the top cover without removing any other parts from the system. Incorrect parts have a '02' suffix, see figure 4, while the correct parts have a '03', see figure 5.

If you have one of the affected systems and would like a replacement backplane, please contact Intel using your normal warranty process, indicating that you are calling regarding TA# 0948-1. Have the following information when you call: the PBA# of the backplane and the MM#, Product Code, and serial number of the affected system(s).

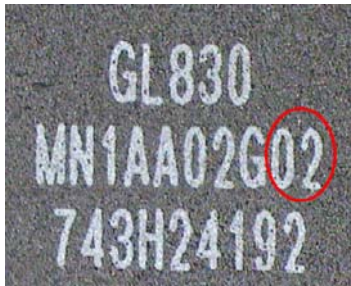
The backplanes of some SR1625, SR2600, and SR2625 systems have been built with an incorrect version of the GL830 converter. It is not possible to load a Linux OS or the Intel Deployment Assistant on a system using a backplane with the incorrect GL830 component. The failure mode will vary depending on the specific version of Linux used but can include a hang or kernel panic.

Figure 4: Incorrect GL830

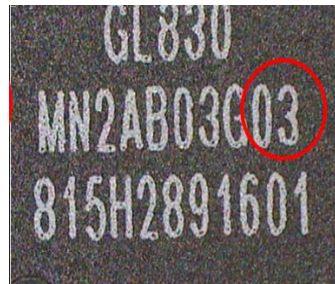
Figure 5: Correct GL830
