# intel® Technical Advisory

TA-720-1

September 20, 2004

## Inadvertently grounding capacitor C305 on backside of board may cause CMOS corruption on Intel® Server Board SE7320SP2 or Intel Server Board SE7525GP2

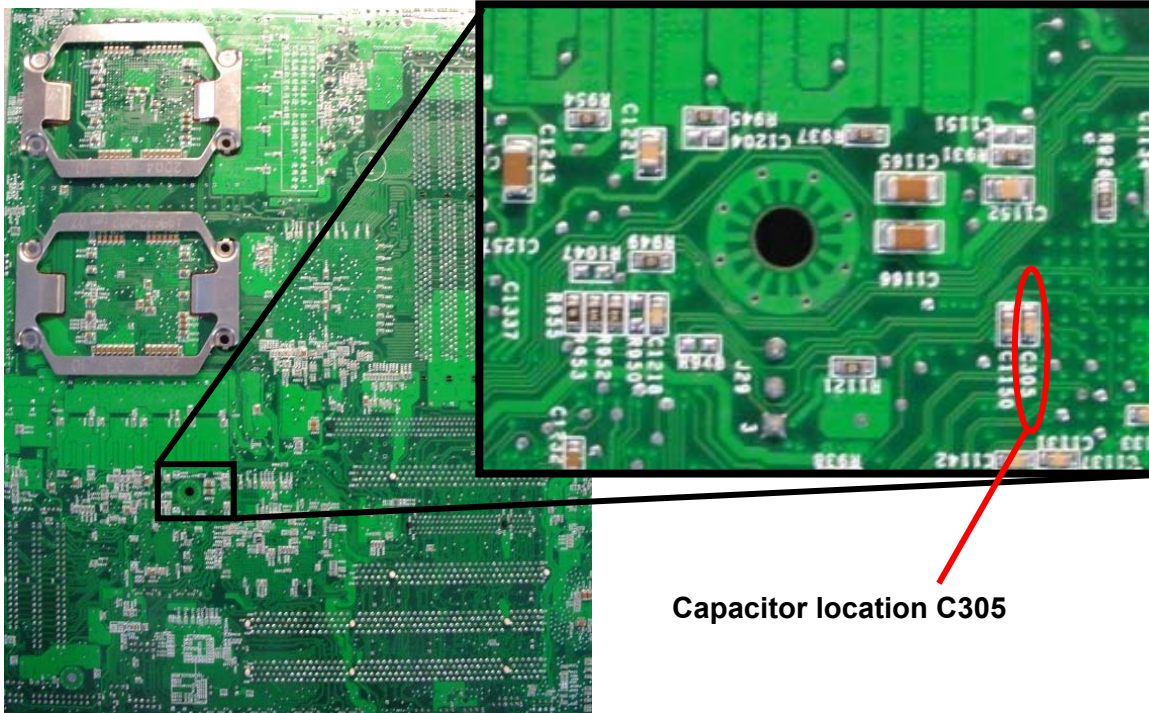
Figure 1 Location of C305

Sightings of CMOS corruption have been observed at the Intel factory and have been traced back to a capacitor on the back side of the Intel® Server Board SE7320SP2 and SE7525GP2 which is part of the CLEAR CMOS circuit. If this capacitor is inadvertently grounded, either by touching a metal surface such as a chassis or by being touched by a human hand, it can lead to corruption of the CMOS settings.

The capacitor at location C305 on the backside of the Intel Server board SE7320SP2 and SE7525GP2 (See Figure 1) has been linked to sightings of CMOS corruption at the Intel factory. This capacitor is a reference capacitor on the RTC\_RST circuit, sitting between this signal and ground. The RTC\_RST signal is an active low signal and is active even when the board is not plugged in since it's part of the CMOS circuit powered by the battery. If this capacitor is inadvertently grounded either by touching a metallic surface such as a chassis or is touched by a human hand, it can pull the signal low enough to cause corruption of the CMOS value.

Capacitor location C305

Intel is in the process of adding a step to the manufacturing line in which a Mylar\* cover is placed over the top of the capacitor, preventing it from coming in contact with any surfaces which may inadvertently cause this behavior. Boards with this Mylar cover will be available after 8<sup>th</sup> of October, 2004 (WW40). Intel will not be making any changes to the TA or PBA numbers on the board for this change.

As soon as possible, Intel will schedule a board change and will relocate this capacitor to the top side of the board where it will be less likely to come in contact with any surface which may accidentally cause this behavior.
