# Intel Technical Advisory

TA-938-01

## The LAN board portion of the AXXRMM2 Remote Management Module may have a rubber bumper that is an incorrect size.

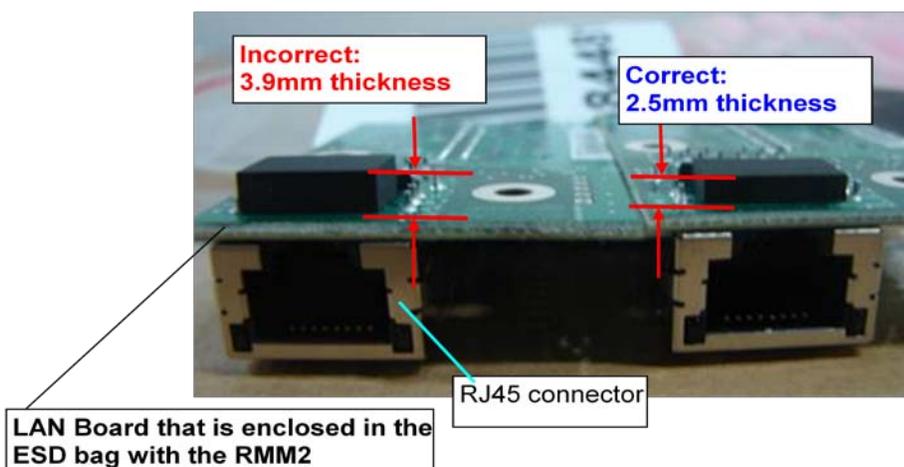
Intel discovered a manufacturing defect in which the rubber bumper that fits on the LAN board of the Remote Management Module 2 (RMM2) is greater than the required 2.5mm thickness.

If the affected LAN board is installed, the RMM2 may become dislodged from the connector in the system. Only customers using the SR1500AL, SR1550AL or SR1560SF systems will be impacted by this issue due to the position of the installed RMM2.

The manufacturer of this component inadvertently mixed in rubber bumpers of the incorrect size.

Customers with product affected by this issue should use their normal warranty replacement process to get replacement boards.
