60- and 66-MHz Pentium® Processor Specification Update

Release Date: February 1997

Order Number 243326-001

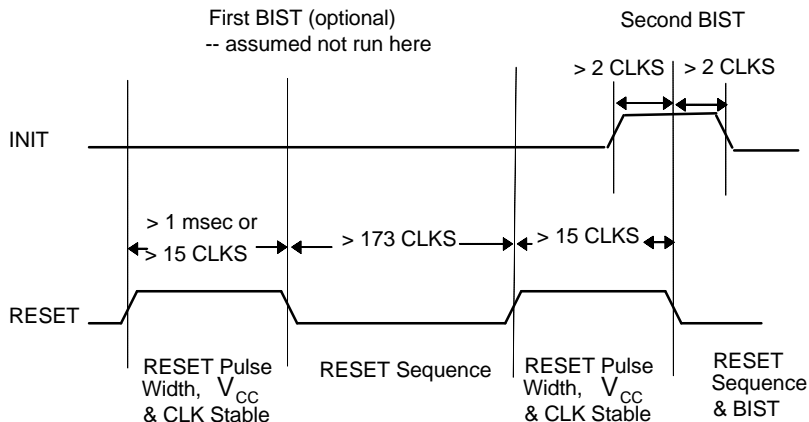
21. Power-Up BIST Failure

PROBLEM: The BIST (Built In Self Test) feature may fail.

IMPLICATION: Upon completion of BIST, a false failure may be reported. That is, a non-zero value may be returned in the EAX register, even though the part is operating correctly. As such, this erratum has no other product or system implications and is fully functional. To date, all observed false failures have returned a value of 20000H in EAX.

WORKAROUND: The root cause of the failure is not yet fully understood. As a result, workarounds suggested in this document are not guaranteed to fix the problem. To Intel's knowledge, however, no BIST failures have been observed with use of either of the workarounds.

1. Invoke a double RESET — All false BIST failures have occurred during cold RESET. In order to accurately execute BIST, a double RESET sequence may be performed as shown in the figure below:

The first RESET pulse is used to ensure that all logic used in the BIST test is correctly initialized; optionally, INIT may be driven high to enter BIST at the falling edge of the first RESET. In this case the results of the first BIST should be ignored.

After deassertion of the first RESET pulse, a minimum of 173 clocks must elapse before assertion of the second RESET. (Note that if BIST was entered at the end of the first RESET, this 173-clock requirement is satisfied by the time required to complete the first BIST.) During the second RESET, INIT is toggled high in order to run the 'real' BIST. This BIST correctly returns results in EAX.

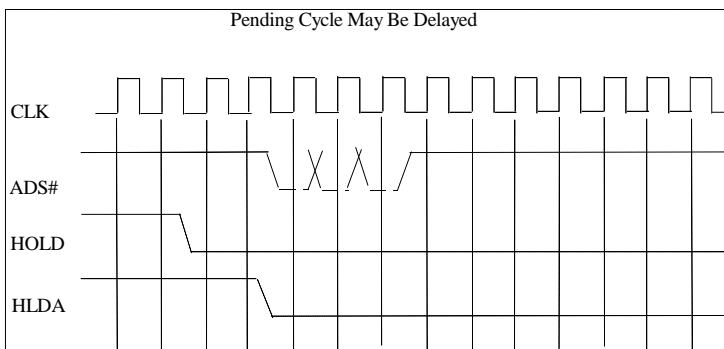
49. ADS# May Be Delayed After HLDA Deassertion

PROBLEM: The Pentium processor typically starts a pending bus cycle on the same clock that HLDA is deasserted. However, it may be delayed by as many as two clocks. See the diagram below.

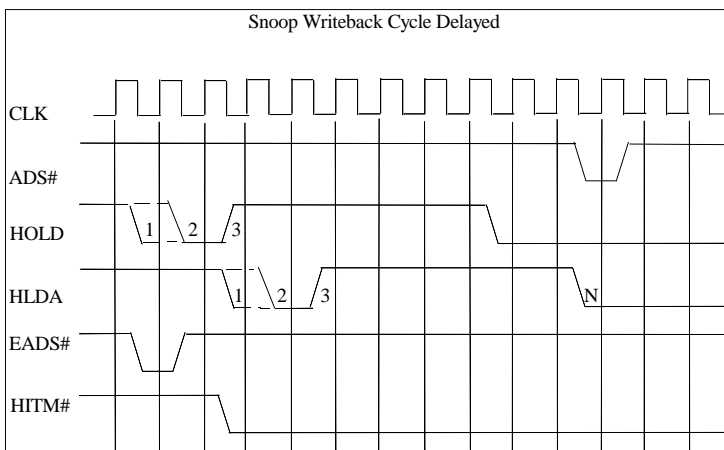
In two cases, for example, if HOLD is deasserted for one clock (i.e., clock 2) or two clocks (i.e., clocks 1 & 2) and then reasserted, the window may not be large enough to start a pending snoop writeback cycle. The writeback cycle may be delayed until the HLDA is deasserted again (i.e., clock N). See diagram below.

IMPLICATION: If the system expects a cycle, for example a writeback cycle, and depends on this cycle to commence within the HLDA deassertion window, then the system may not complete the handshake and cause a hang.
