Intel[®] Pentium[®] III Processor Specification Update

Release Date: May 2005

Document Number: 244453-055

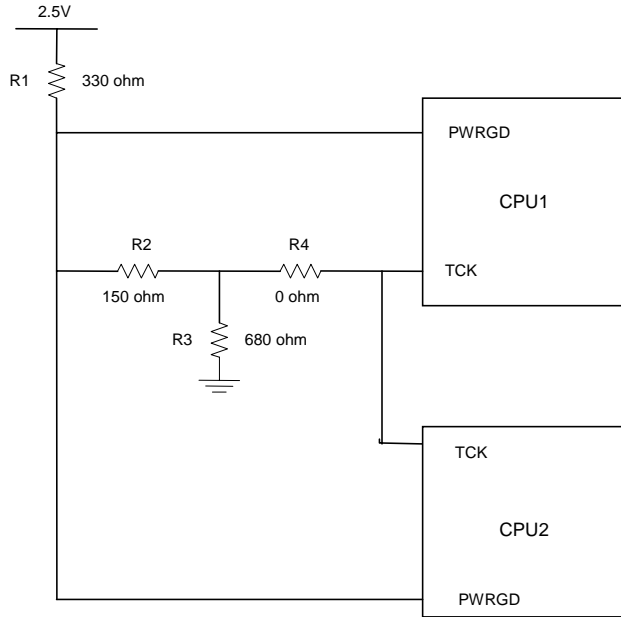
Pentium® III Processor with 512KB L2 Cache Platforms Workaround

Assumes the inputs to the CPU_PWRGD are open collector signals that are Wire-ANDed together

- The example workaround circuit assumes that the PWRGD inputs into the processors are open collector. Tying the PWRGD inputs together in a Wired-AND fashion allows each processor to receive PWRGD at the same time but at the latter of the 2 separate PWRGD assertions. If separation of the PWRGD inputs to each processor is required, extra circuitry will be required.
