Intel Technical Advisory

5200 NE Elam Young Parkway Hillsboro, OR 97124 TA-0899-2

June 11, 2008

Virtual Drive Expansion May Cause Physical Drives to be Marked Dead on the Intel® Modular Server System MFSYS25

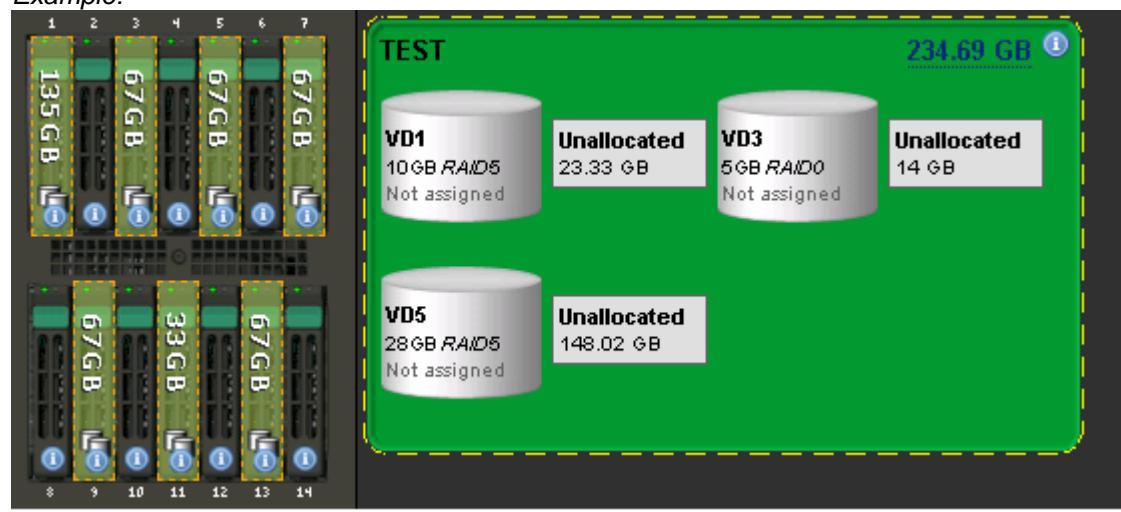
Example:

In the configuration shown above, there is 185.35GB (23.33 + 14 + 148.02) of 'total unallocated space' in the entire storage pool. However, there exists only 162.02GB (14 + 148.02) of cumulative unallocated space **after** VD3's position in the Storage Pool. In this state, expanding the RAIDO Virtual Drive (VD3) by 170GB would result in this error condition. This is because there isn't 170GB of cumulative unallocated space remaining in the storage pool after this Virtual Drive's position in the Storage Pool (there is only 162.02GB (14 + 148.02) of cumulative unallocated space available after the Virtual Drive). Current software for the storage subsystem would allow this operation to proceed since there exists more than 170GB of total unallocated storage space within the entire Storage Pool. However, during the expansion of VD3, all Physical Drives in the storage pool would be marked as "Dead" and all virtual drives in the pool would be placed "Offline". The Storage Pool and all Virtual Drives within the storage pool would become unavailable and would NOT be recoverable.

Note that it is unusual to have a Storage Pool configuration where unallocated space appears prior to or between Virtual Drives within a Storage Pool. These blocks of unallocated space between Virtual Drives only occur when a previously created Virtual Drive is deleted and not replaced with a new Virtual Drive.

When a Virtual Drive is expanded to include more space than the cumulative unallocated space available after its position in the Storage Pool, the Virtual Drive's expanded capacity is inaccurately calculated resulting in errors in how the data is rewritten to the Physical Drives. This causes the Physical Drives to be marked 'dead' which causes the Virtual Drives to be marked 'offline'.

Revision P 2.2.3 software for the Intel® Modular Server System MFSYS25 contains new firmware which corrects this issue. This software release is available for download from Intel's support website and is planned to be cut into factory production mid-June.
