Intel Technical Advisory

TA-0970-1

January 25, 2011

MFS5000SI, MFS5520VI, MFS5520VIR SAS Initiator ID change after update to Unified Firmware Update V6.0 or higher

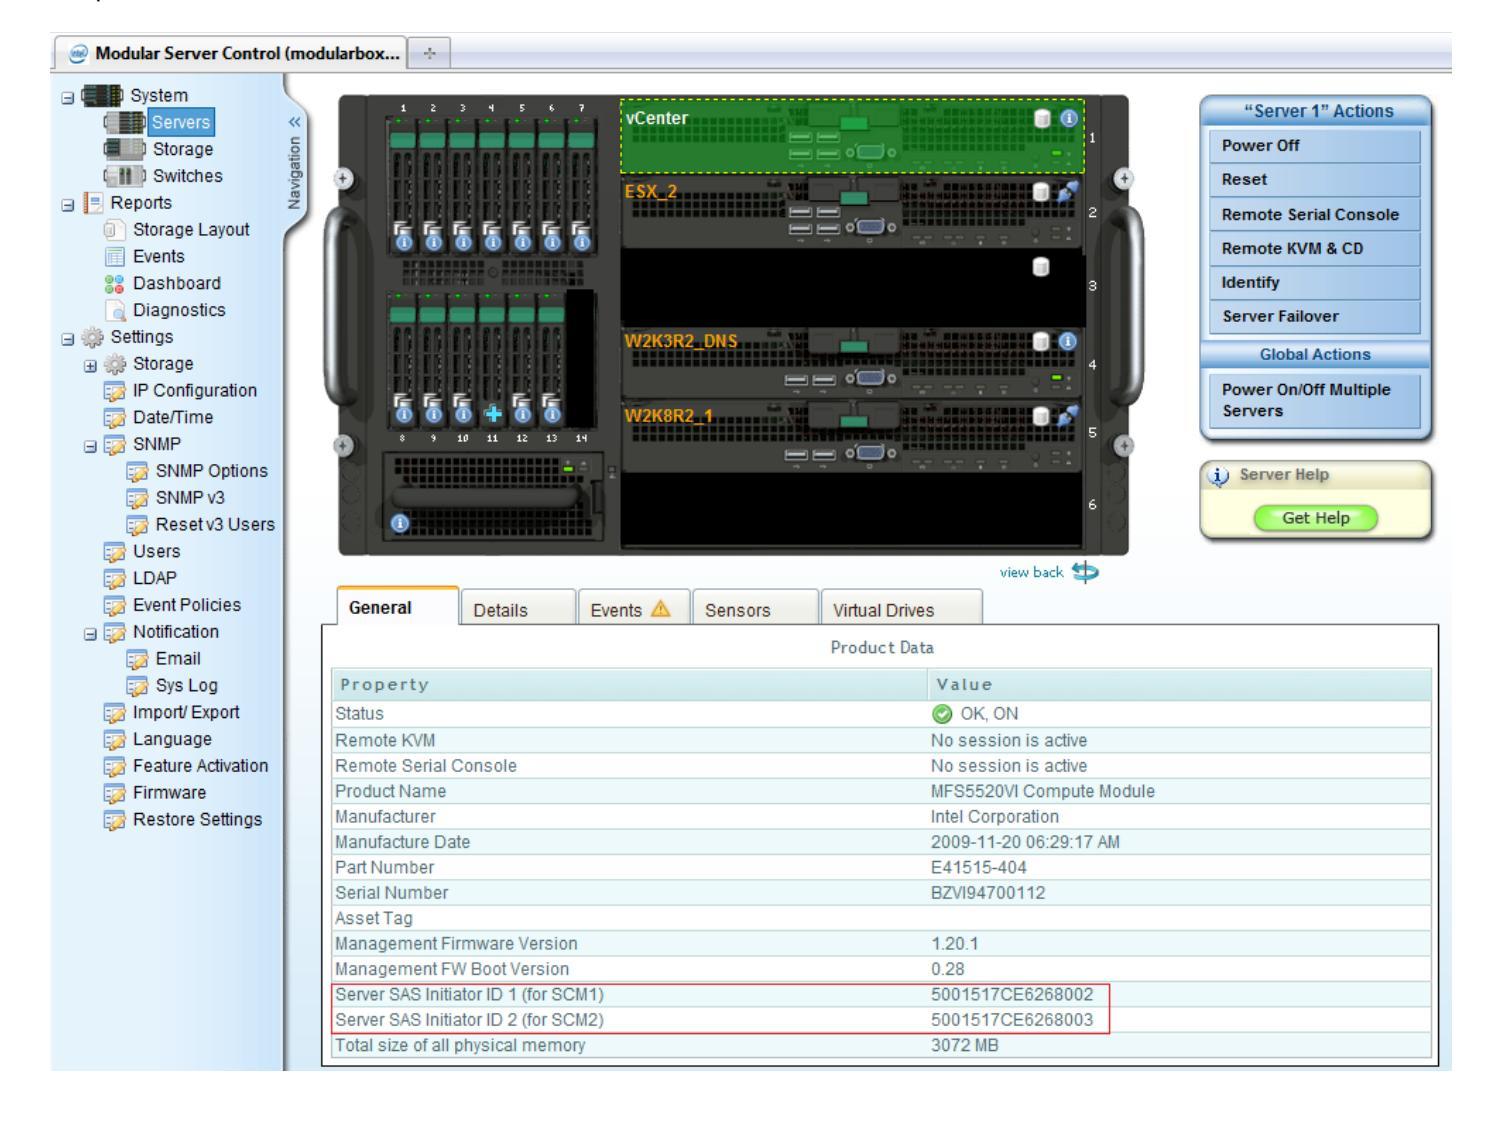
The MFS5000SI and MFS5520VI onboard SAS controller LSI1064E SAS Initiator ID last digit will increment after a Unified Firmware Update from UFU V5.5 or lower to UFU V6.0 or higher. Each compute module has a unique SAS Initiator ID for each SCM installed in the MFSYS25/MFSYS35 chassis. The SAS Initiator ID is not used for mapping of internal storage within the MFSYS25/MFSYS35 chassis. Internal Virtual Drive are not affected by the changes to the SAS Initiator IDs. However, the SAS Initiator ID is used for mapping of LUNS within an external array to a particular compute module within the MFSYS25/MFSYS35 chassis.

Customers with MFSYS25/MFSYS35 with an external array should be aware of the change in SAS Initiator ID after updating to UFU V6.0 or higher. Prior to updating to UFU V6.0 or higher, customers should record the exact mapping of LUNs to SAS Initiators as well as the SAS Initiator ID for each compute module in a table. The SAS initiator ID for a compute module is found within the Intel Modular Server Control GUI as shown below:

After the firmware update has completed, customers should go into the Intel Modular Server Control GUI and record the new SAS initiator ID for each computed module next to the previously recorded ID in the table created prior to the update. Once the new table with updated SAS Initiator IDs for each compute module has been recorded, the LUNs in the external array can be remapped to the new SAS Initiator IDs for each compute module.
