Intel Action Alert AA-0896-1

February 21, 2008

Intel® Remote Management Module 2 May Fail When First Installed

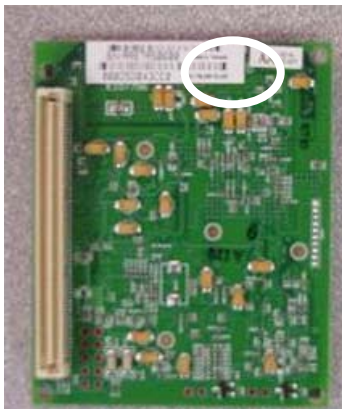
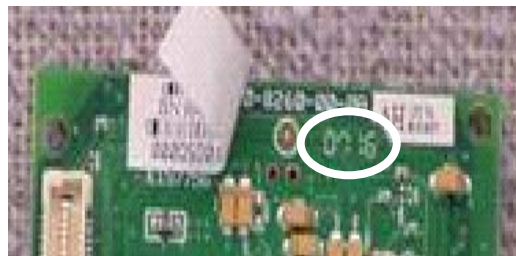
1. Open the Intel® RMM2 cardboard box. The box contains two static bags and one clear plastic bag. The Intel® RMM2 is the 2 x 2 inch device in a static bag.
2. Open the warning seal on the static bag containing the Intel® RMM2 and remove the module. Be sure to follow the ESD precautions above
3. Locate the larger white label (serial number) on the bottom side of the module. (See figures below).
4. VERY CAREFULLY, raise the right edge of the label enough to see the 4 digit date code on the green board underneath. In some cases, the smaller label on the right side may need to be raised on its left side.

NOTE: Do NOT use anything sharp that might scratch or mar the PCB surface to raise the label. These labels should be pushed down and fully reattached to the boards after viewing the code.

5. If you have an Intel® RMM2 with the “0716” date code, use the following instructions to return the module to Intel for a replacement.
 - a. **Contact Intel using your standard method to set up an RMA.**
 - b. **Include the following information**
 - 1) **Issue AA-0896-1**
 - 2) **Part # (D84579-10x)**
 - 3) **Serial number (from the white sticker that was peeled back)****Note: For multiple boards, each serial number and part # must be provided.**
