# Monthly Specification Update

**Intel<sup>®</sup> Server Board S5000PAL**

*Intel Order Number D65289-033*

**April 2010**

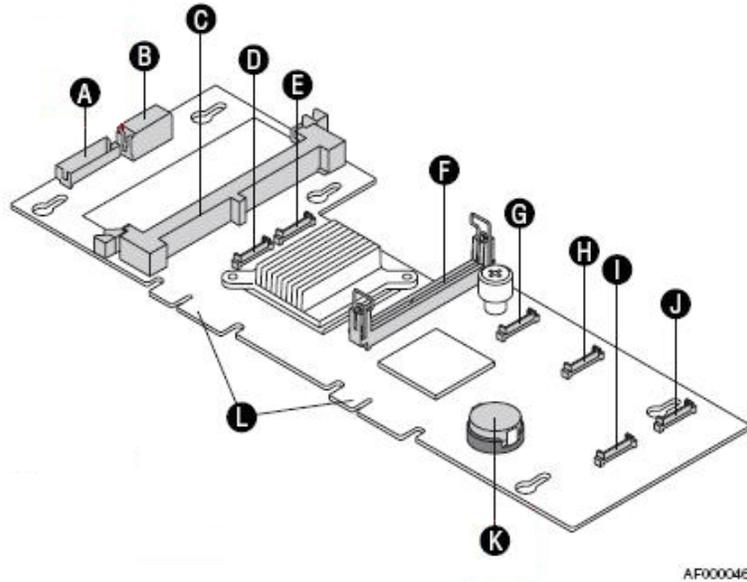
Figure 22. SAS/SAS RAID Mid-plane Board

**3. SAS/SAS RAID midplane board (Figure #22) as provided in Rev.1.0 of the Intel<sup>®</sup> Server System SR2500AL TPS should swap the descriptions of items A and K**

3.	Fix	Intel <sup>®</sup> Server System SR2500AL Technical Product Specification Rev. 1.0	SAS/SAS RAID mid-plane board (Figure #22) as provided in Rev.1.0 of the Intel <sup>®</sup> Server System SR2500AL TPS should swap the descriptions of items A and K.
