# Intel<sup>®</sup> Integrated RAID Controller SRCMRU

Specification Update

December 2002

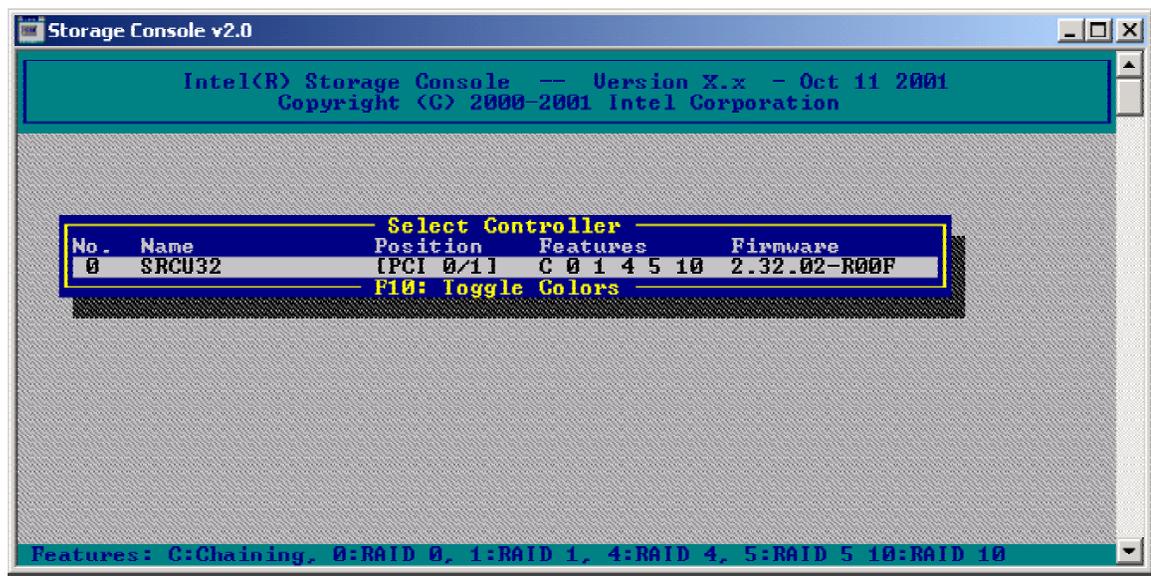
Figure 2. Firmware Version and Application Version Displayed in Storage Console  
Console Version Identifier

An alternative method is to use Storage Console for identifying the adapter firmware version. Within Storage Console, select the applicable controller and locate the firmware version at the bottom right corner of the window. See [Figure 2](#).

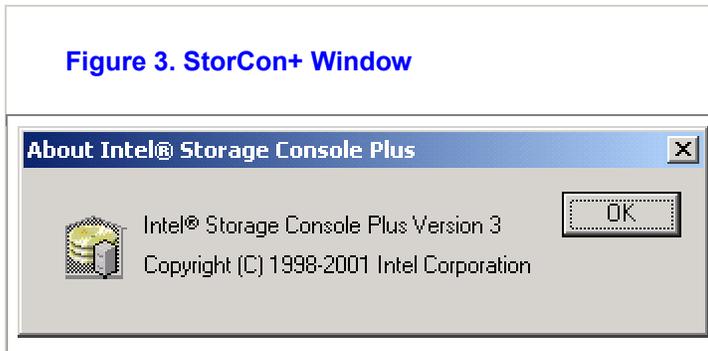
The StorCon version is displayed on the top middle area of the StorCon window. See [Figure 3](#).

The StorCon+ version is displayed on the of the StorCon+ window. See [Figure 3](#).
