Intel[®] Server RAID Controller U3-1L Low Profile (SRCU31L)

Specification Update

June 2001

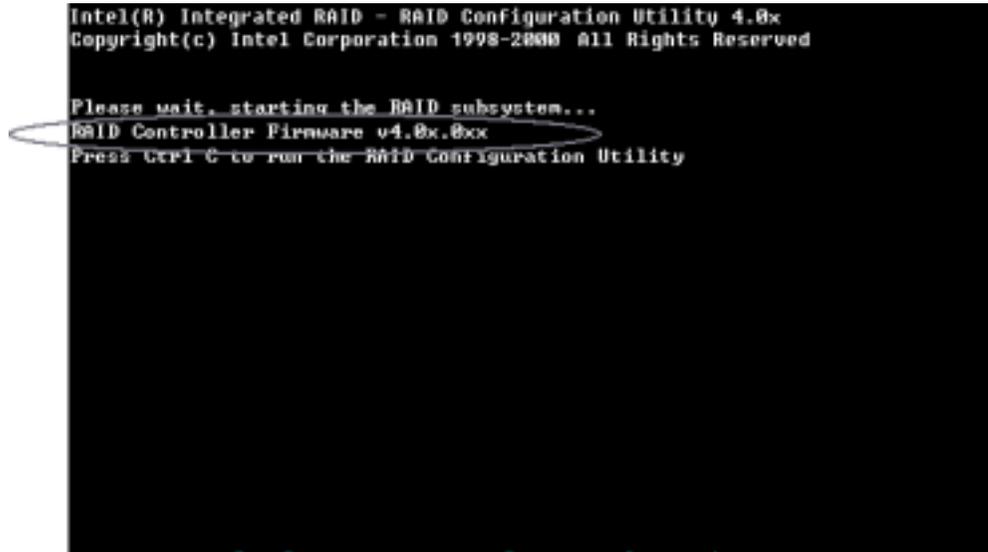
Figure 1. Firmware Version Displayed in RCU

There are two methods for identifying the firmware version installed on the RAID adapter. While the system is booting, the RAID controller firmware initializes and displays the information shown in [Figure 2](#) to the screen. The firmware version is displayed next to the words “RAID Controller Firmware”.

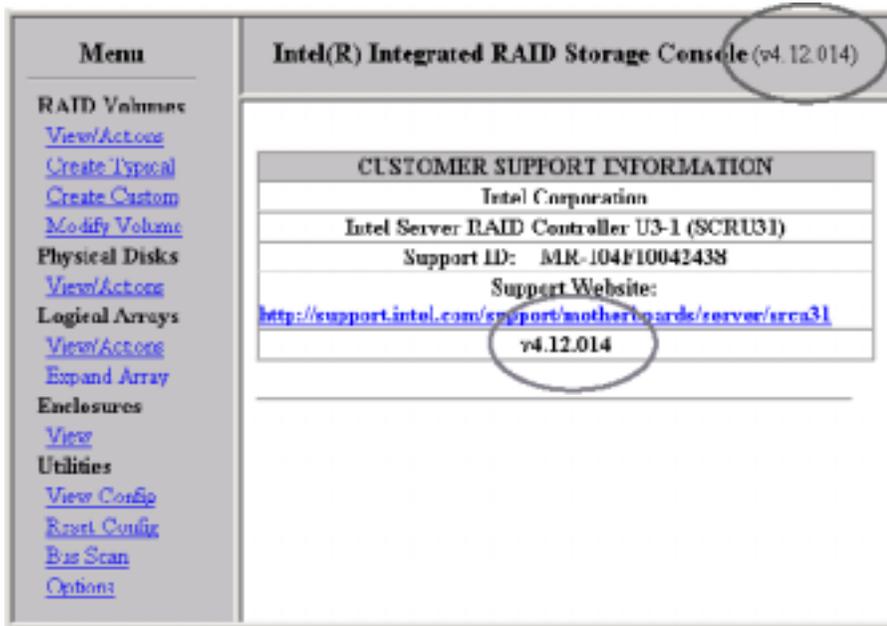
Figure 2. Firmware Version Displayed in Storage Console

An alternative method for identifying the adapter firmware version requires that the system be booted into the host operating system running the Storage Console application. With Storage Console running, select “Options” in the left frame and then “Support Info” in the right frame. The firmware version is listed in the table next to the words “Build Version”. See [Figure 2](#).
