**Intel® Core™2 Extreme Quad-Core  
Mobile Processor, Intel® Core™2  
Quad Mobile Processor, Intel® Core™2  
Extreme Mobile Processor, Intel®  
Core™2 Duo Mobile Processor, Intel®  
Core™2 Solo Mobile Processor and  
Intel® Celeron® Processor on 45-nm  
Process**

**Specification Update**

*November 2008*

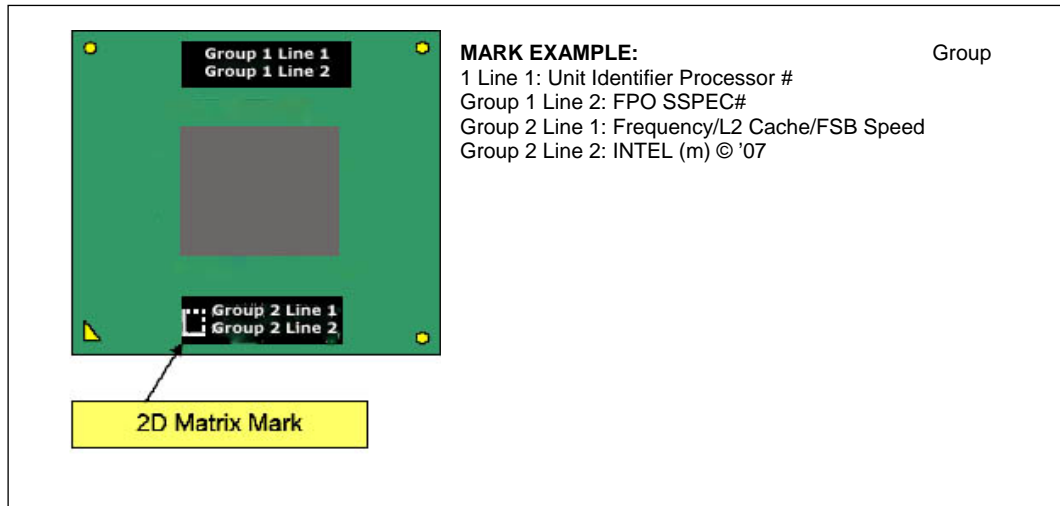
Figure 1. Processor S-Spec Top-side Markings (Example)

The processor stepping can be identified by the following component markings:
