Mobile Intel[®] Pentium[®] III Processor and Mobile Intel[®] Pentium[®] III Processor-M

Specification Update

Version 059

Document Number: [245306-059](#)

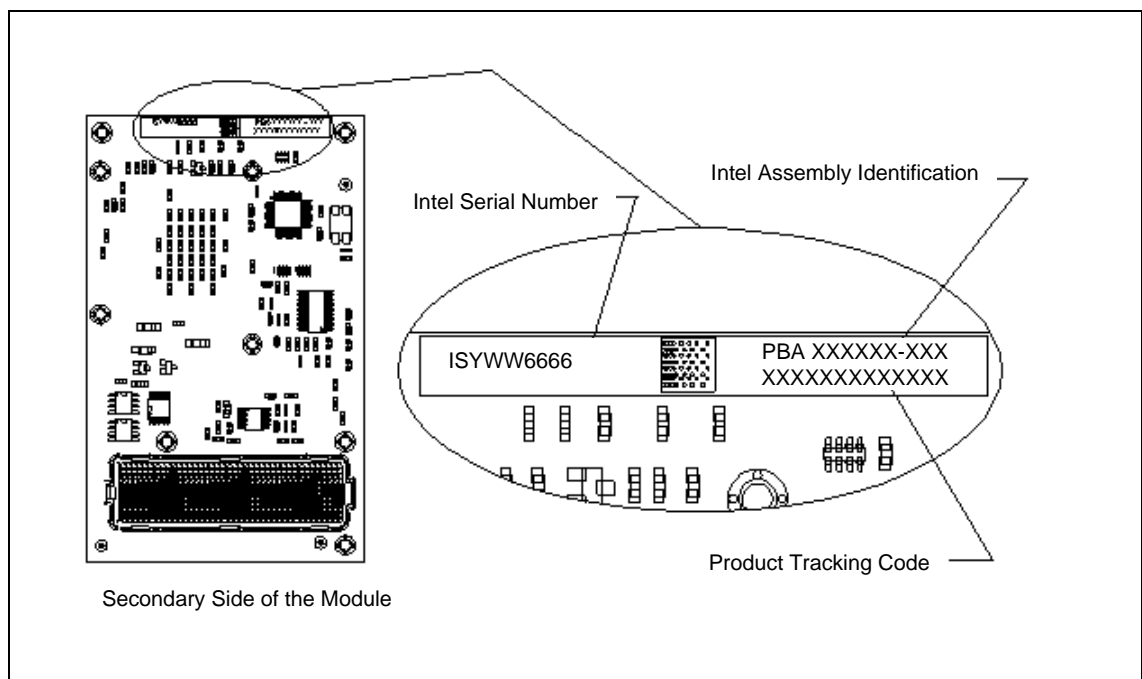
Intel® Pentium® III Processor Mobile Module Markings

For other Intel Mobile Modules, the second field (B) is defined as:

Pentium® II Processor Mobile Module (MMC-1) = D
Pentium® II Processor Mobile Module (MMC-2) = E
Pentium® II Processor Mobile Module with On-die Cache (MMC-1) = F
Pentium® II Processor Mobile Module with On-die Cache (MMC-2) = G
Celeron® Processor Mobile Module (MMC-1) = H
Celeron® Processor Mobile Module (MMC-2) = I
Celeron® Processor (.18μ) Mobile Module (MMC-2) = N
