Intel[®] Xeon[®] Processor MP

Specification Update

October 2005

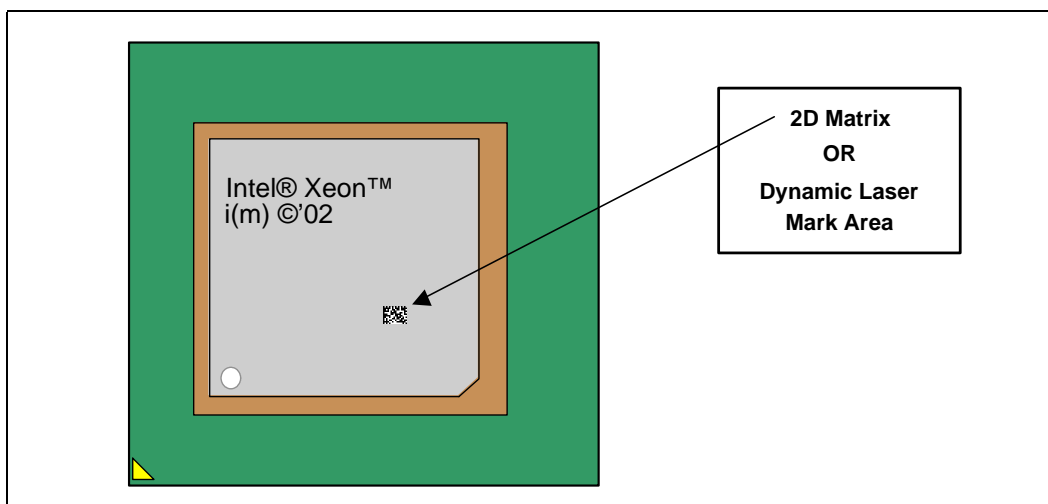
Intel® Xeon® Processor MP and Intel® Xeon® Processor MP with up to 4MB L3 Cache (on 0.13 Micron Process) Markings (603-pin INT-mPGA)

Figure 1. Top Side Processor Marking – Production Part

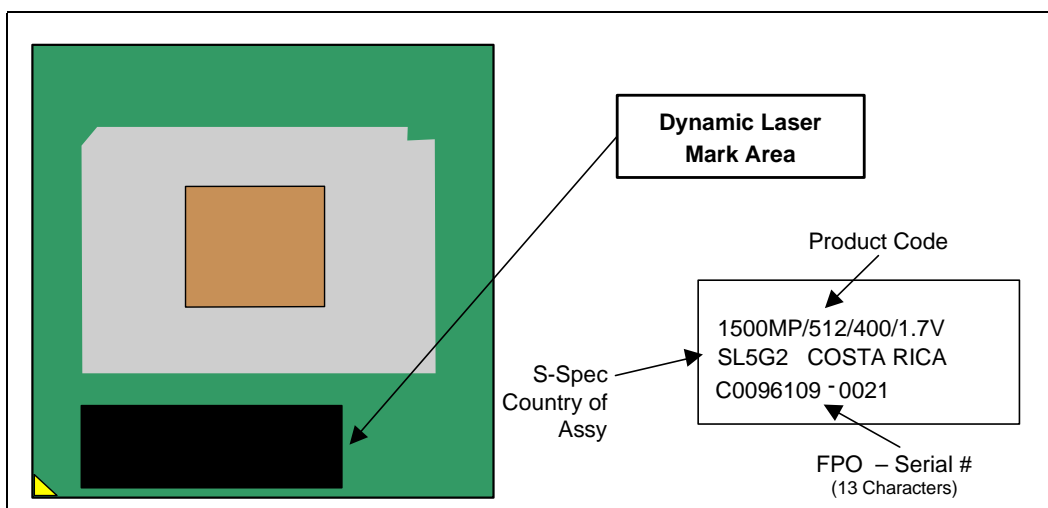
Figure 2. Bottom Side Processor Marking
