64-bit Intel[®] Xeon[®] Processor MP with 1 MB L2 Cache

Specification Update

June 2006

Document Number: 306752-011

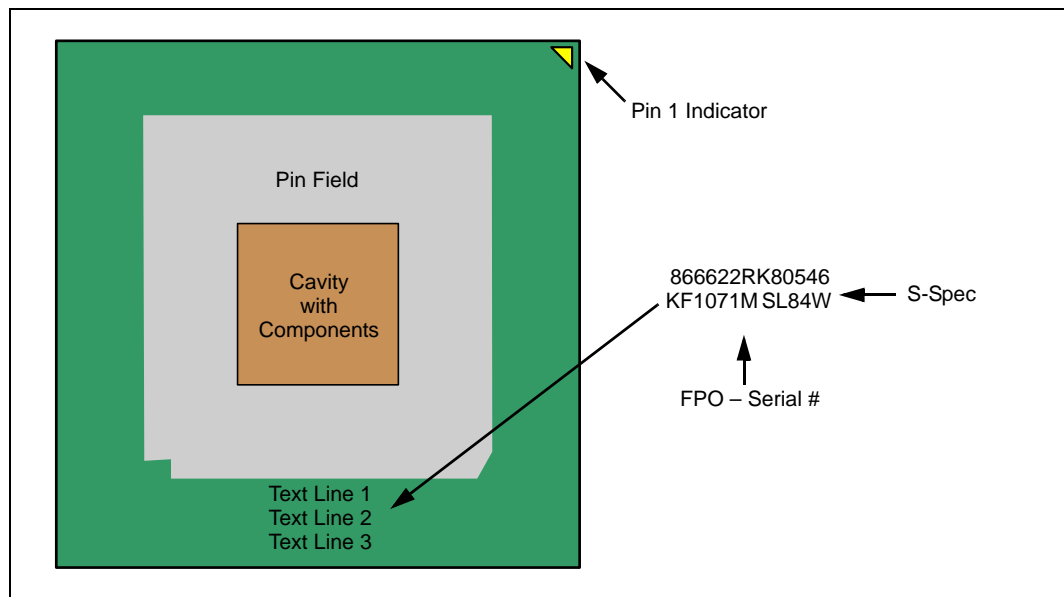
Figure 2. Bottom-Side Processor Marking Example
